Appendix B Case Histories

Ice Harbor Lock and Dam, Downstream Navigation Lock Gate Replacement

Locks No. 7, Upstream Gate, Downstream Gate Leaf Replacement

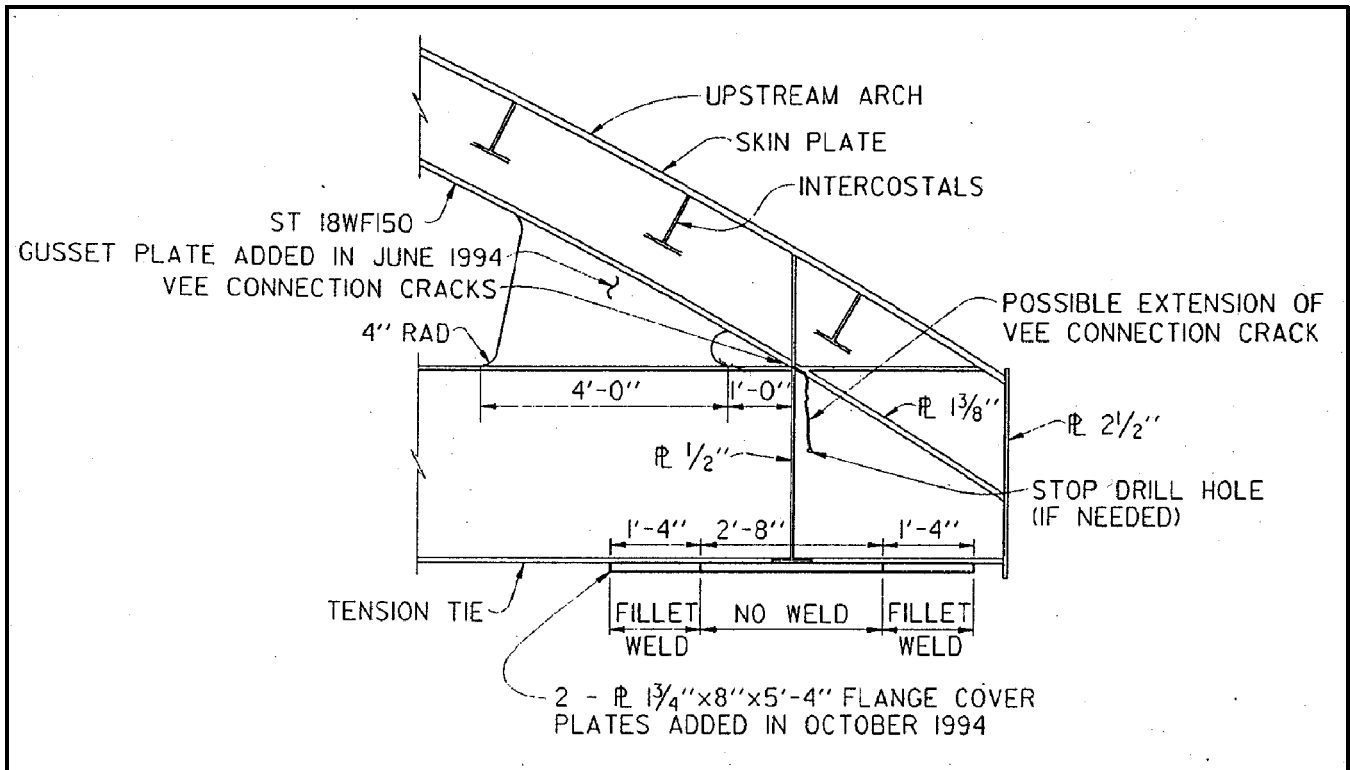
Figure B-1. Vee connection cracks and addition of gusset plate and flange cover plate for the existing gate

(1) The heat-affected zone at the vee created large residual stresses that may have led to crack development. The vee connection creates a high stress zone due to its geometry.

both flanges and into the web. There were no documented repair procedures; however, repairs consisted of welding cover plates over the cracks in the flanges. Cracks did not appear again until June 1992 when four large cracks were observed and later repaired near the bottom of the gate, at the vee, the intersection of the tension tie girder, and the upstream arch compression member. From 1980 to 1992, the only other incidences of repairs were the the hoisting drum bearings, gear boxes, shafts and hydraulic units in 1989, and in 1991 replacement of guide roller with a compressible shoe. After new cracking developed in 1992, additional cracks were found in August 1993, some located at intersections of diagonals and tension tie girders, others at the vee. Figures B-1 and B-2 represent the typical location of the cracks where holes were recommended for drilling to stop the crack propagation. All were in the lower part of the gate. Because project forces could not keep up with the numerous cracks and crack growth between scheduled outages, a construction contract was required to finish the welding cracks during a scheduled 2-week outage in March 1994. Results from a three-dimensional finite element model of the gate indicated that the diagonal bracing contributed to out-of-plane bending in the tension tie girders, hence increasing the stress in the flanges. Therefore, part of the welding contract required that all diagonal and vertical bracing be removed, with all gouges and sharp edges ground smooth. After the welding was completed, cracking continued. By May 1994, 80 cracks had developed on the gate. Where bracing was removed, the cracking decreased; however, the incidence of cracking at the middle and upper levels of the tension tie girders increased. By June 1994 the total number of cracks increased to 130, almost all on the downstream flange of the tension tie girder. To provide a margin of safety to the integrity of the gate, gussets were added at the vee in the lower six tied arches to reduce high stress. They were designed to carry a portion of the arch load, bypassing a crack in the flange in the vee.

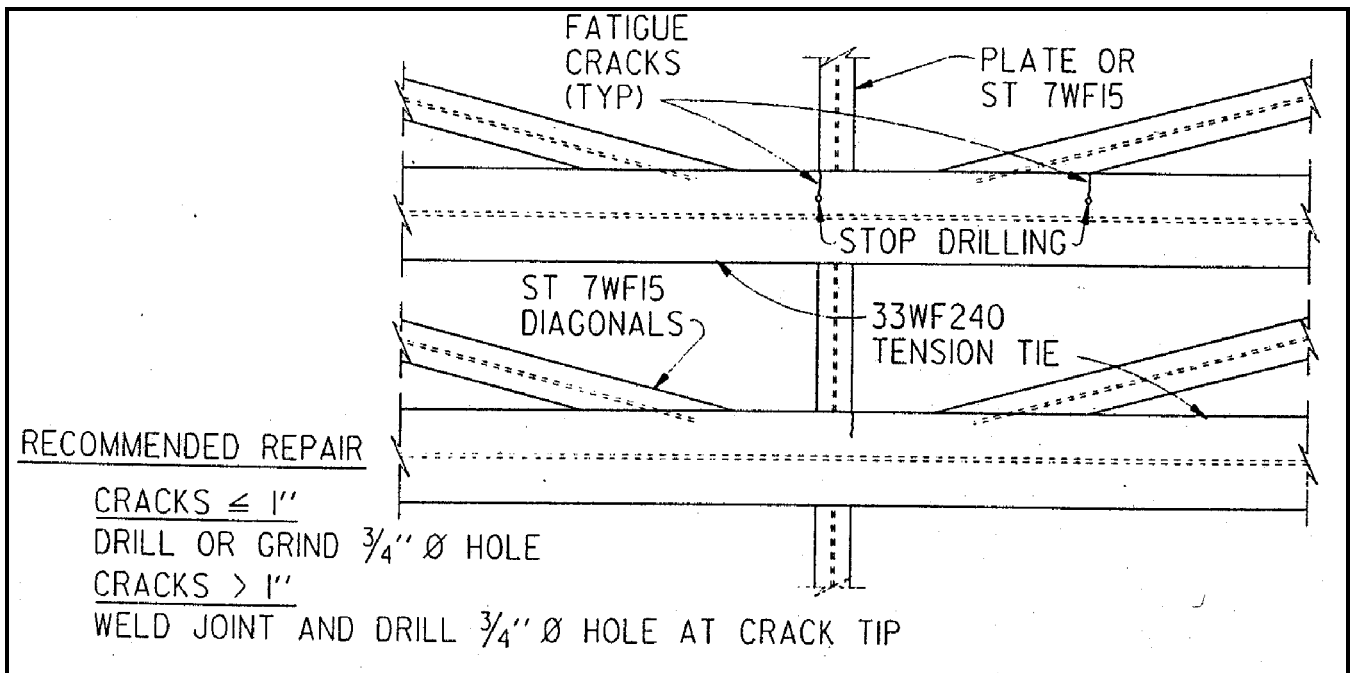
Figure B-2. Typical cracking located at downstream bracing to tension tie flange

b. Findings of investigations. The tension tie girders experienced a significant amount of cracking on the upstream flange near the vee. Numerous cracks formed on the downstream flange at the diaphragm and downstream bracing. Virtually all cracks start at the tip of welded joints. The

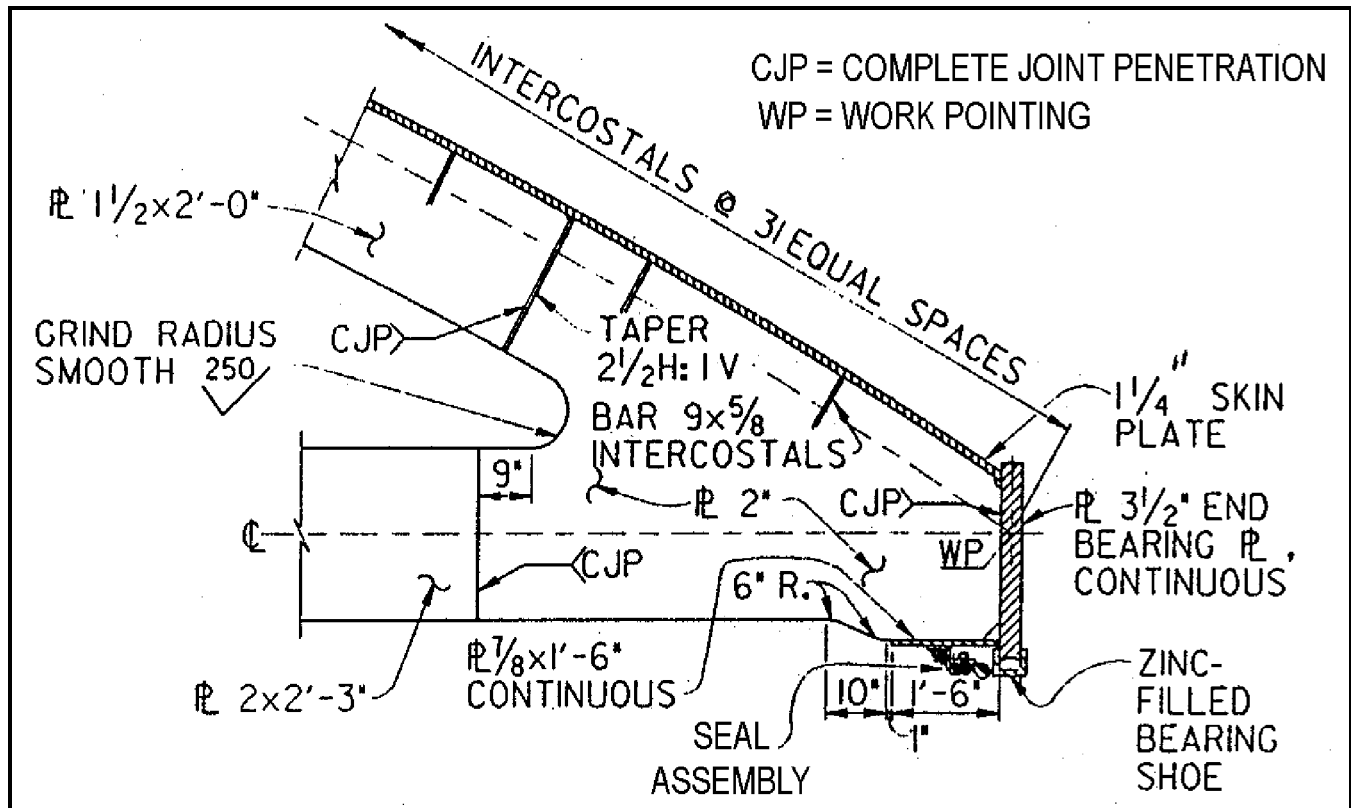
Figure B-3. Connection of compression arch to the tension tie and end bearing plate for the replacement gate

a. Design and structural configuration. Considered in the preliminary design was the type of connections, particularly revising the vee to a radius, to eliminate high stress risers at the connection of the arch to the tension tie. The preliminary design phase was used to develop connections and construction methods that would eliminate connections in high fatigue categories. By using a flat plate for the tension tie, rather than

a rolled or plate girder, and providing a continuous plate with a radius at the inside corner, category E connections could be avoided. Figure B-3 represents the structural configuration for connection of the compression arch to the tension tie. Preliminary member sizing was performed using hand calculations. Final design was performed using a three-dimensional finite element analysis. A refined model of the connection of arch to tension tie was performed to determine the radius required and resultant stresses. The general gate model consisted of 8,931 three-dimensional single-order quadrilateral shell elements and 1,506 three-dimensional beam elements. Because of large, out-of-plane friction forces that develop under hydrostatic load, stress analysis of the end post (plate) was performed using three-dimensional solid elements. The final design included tension ties consisting of 50- by 686-mm (2-in. by 2-ft 3-in.) plate lying flat, with vertical bracing at 3353-mm (11-ft) intervals. Vertical bracing and hydrostatic loads were resisted with a plate girder located at the top spanning the width of the gate. The skin plate was 32 mm (1 1/4 in.) thick with intercostals spanning the arch plates in the upper third of the gate. The arch consisted of 38- by 610-mm (1-1/2 in. by 2-ft) plate. Loads were transferred to end bearing plates in the concrete through an 89-mm- (3-1/2-in.-) thick end post (plate). Side rollers were replaced with a compressible shoe to eliminate crushing of the steel
